Water Compliance Inspection Report				
Transaction Code NPDES	Section A: National Data Coding (i.e.	, PCS) Inspection Inspe	ector FacType	
		Туре	1 1 1 1	
1 N 2 5 3 T N R 0 5 0	5 6 4 11 12 1 1 0 5 2 7 7 Remarks	17 18 ~	19 S 20 2	
21				
Inspection Work Days Facility Self-Monitoring Evaluation BI QAReservedReserved				
67 3 69 70 2 71 N 72 N 73 74 75 80				
Section B: Facility Data				
Name and Location of Facility Inspected (For indu POTW name and NPDES permit number)	istrial users discharging to POTW, also include	Entry Time / Date	Permit Effective Date	
Fleischmann's Yeast		9:15 AM / 5/27/11	11/10/09	
2743 Riverport Road		Exit Time / Date	Permit Expiration Date	
Memphis, TN 38109		11:00 AM / 5/27/11	5/14/14	
Name (a) of Oc Oile Days (b) (c) (c) (c)				
Name(s) of On-Site Representative(s)/Title(s)/Phone and Fax Number(s)		descriptive information)	Other Facility Data (e.g., SIC NAICS, and other descriptive information)

On May 27, 2011, Mrs. Maylynne Pynkala and Mrs. Lindsay Barrios conducted a Compliance Evaluation Inspection (CEI) at the Fleischmann's Yeast facility located at 2743 Riverport Road in Memphis, Tennessee. We met with Mr. Rick Leggett (Bioprocessing Manager) and Mr.

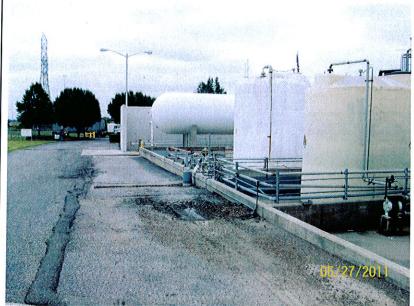
The tank farm area consists of seven aboveground storage tanks that average about 6,000 gallons each (photo 1). They are located east of the plant structure and across from the molasses storage tanks. All of the tanks are in concrete spill containment pits large enough to hold the tank contents plus rainfall. The contents of the tanks are Defoamer Oil, Sulfuric Acid, Phosphoric Acid,

Nitric/Phosphoric Acid, 50% Caustic (Sodium Hydroxide), Diesel Fuel, and Propionic Acid. The chemicals are pumped to the plant via a concrete lined subsurface pipe chase. Anything discharged into the containment area is piped to the process drain then into the sanitary sewer effluent sump.

Photo 1) View of a portion of the tank farm and its containment area.

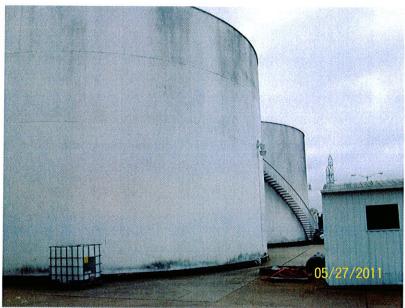
Molasses storage tanks (each approximately 600,000 gallons in capacity) are located on the northeast corner of the property (photo 2), across from the tank farm. Molasses is received either by barge or rail. There is a transfer pipeline from the dock to the molasses tanks. The tanks are surrounded by an unconfined concrete pad. Molasses is pumped to the facility via piping in a concrete lined subsurface piping chase. According to Mr. Leggett, any spills from the molasses tank area are discharged into the sanitary sewer.

Photo 2) View of two of the six molasses tanks at the facility.

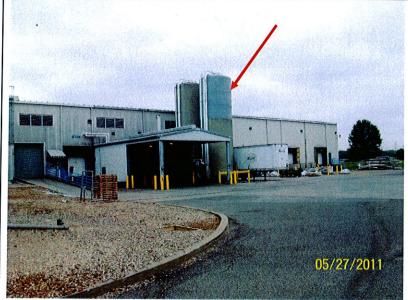
A cream yeast loading station with two cream yeast tanks is located outside directly between the first and second shipping docks at the rear of the plant. Effluent drains to the sanitary sewer are located in the immediate area of this loading station and west of the loading station with a dike on the north and south sides (photo 3).

Photo 3) View of the loading dock areas and cream yeast storage tanks (arrow).

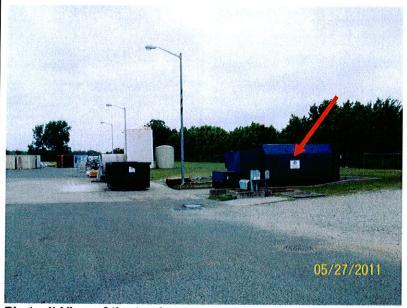
A 34 cubic yard self-contained trash compactor is located on the edge of the rear lot, on a concrete pad, diked on three sides. The compactor is used for office trash, break room & non-biohazardous laboratory waste, plastic wraps, cardboard and packaging product waste. The compactor is completely enclosed (photo 4).

Photo 4) View of the trash compactor (arrow) and 3 dikes around the compactor.

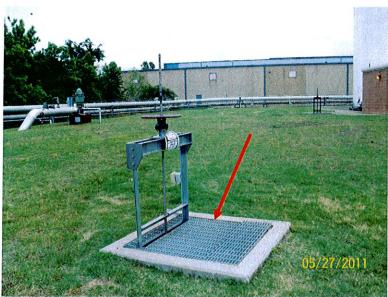
Outfall SW1, which discharges directly into McKellar Lake, is located on the north side of the property (photo 7). There is a surface drainage inlet with a sliding gate valve located near Outfall SW1 (photos 5-6). At the time of inspection, the gate valve was open and storm water was discharging from Outfall SW1, due to a recent rain event on March 25, 2011. Oil sheen was observed in the surface drainage inlet structure (photo 6). According to Mr. Leggett, oil had accumulated in the surface drainage inlet as a result of Mississippi River floodwaters flowing back up into the storm drain system.

Photo 5) View of the surface drainage inlet (with a sliding gate valve) leading to Outfall SW1. At the time of inspection the gate was open (see photo 6).

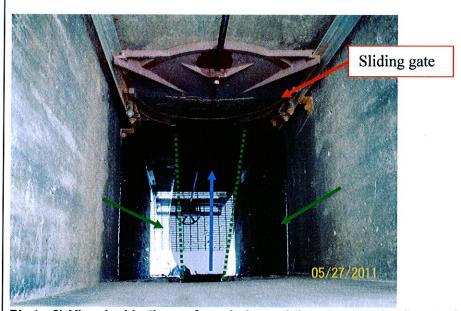
Photo 6) View inside the surface drainage inlet structure leading to Outfall SW1, showing the sliding gate (red arrow). Oil sheen was observed in the inlet structure (green arrows). Storm water was observed flowing through the inlet structure towards Outfall SW1 and McKellar Lake (the blue arrow shows direction of flow).

At the time of the inspection, there was a storm water discharge observed at Outfall SW1. Oil sheen was noted in the surface drainage inlet structure. Mr. Leggett indicated that the oil sheen was from the recent flooding of the Mississippi River that had caused flood waters from McKellar Lake to back up into the facility's storm drain system. According to Mr. Leggett the oil came from McKellar Lake.

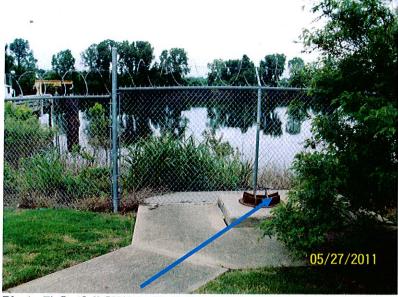
Photo 7) Outfall SW1 to McKellar Lake.

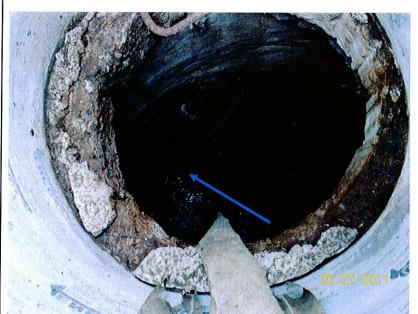
Photo 8) View of storm water flowing out of the storm drain towards Outfall SW1 and McKellar Lake. The arrow shows the direction of flow.
